COIMBRA FISHWAY

Restoring connectivity in River Mondego

Groningen, June 2015

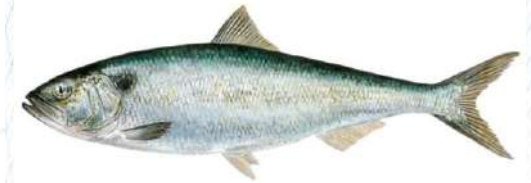
In 2011, after several years of biological and hydraulic monitoring and studies, a new vertical-slot pool type fishway was built, near the old one, in order to restore river connectivity.

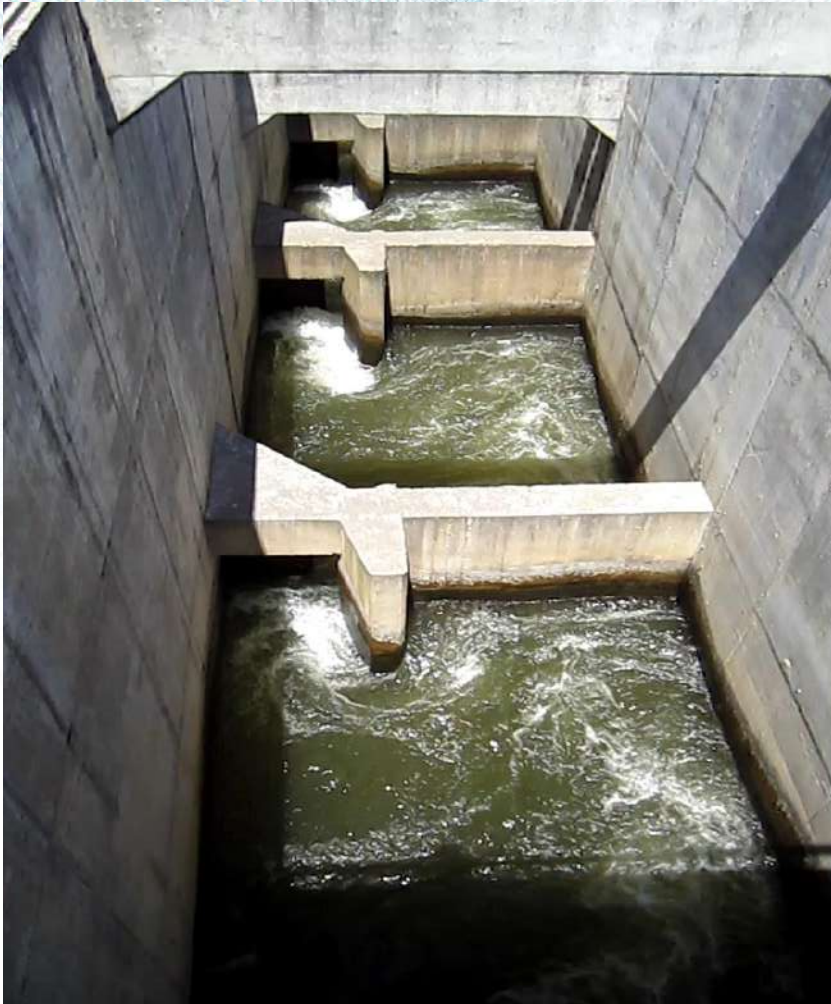
Fishway characteristics
Total length	125m
Number of pools	23
Length and width of each pool	4,5x3m
Flow inside the fishway	Between 1 - 1,5 m ³ /s
Water height in the pools	Between 1 - 2 m
Dissipated power	<150 Watt/m ³

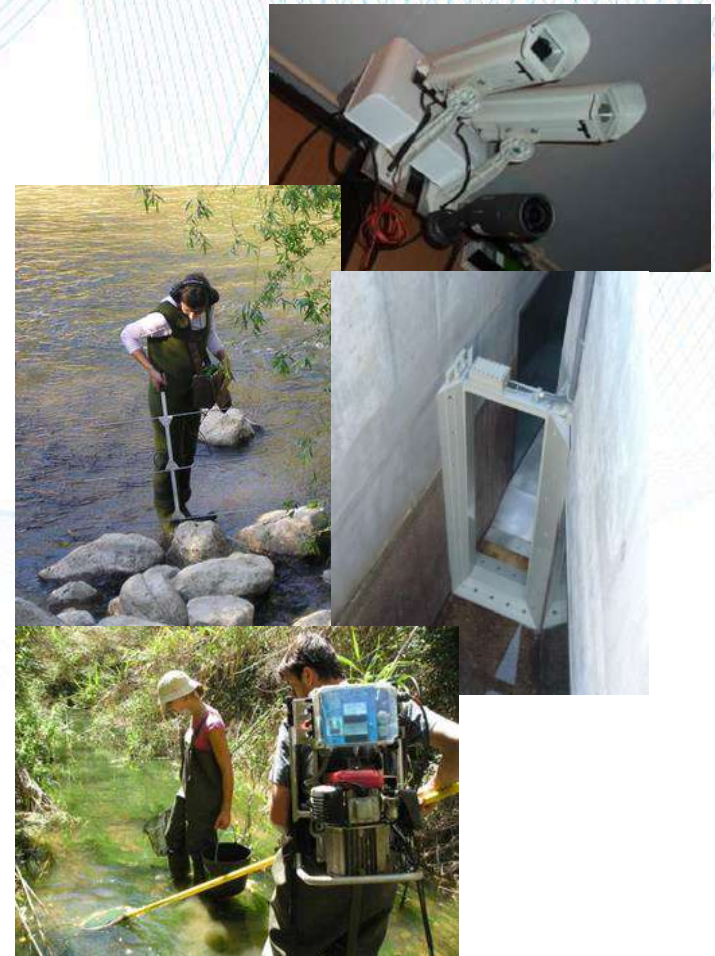
The Coimbra fishway was monitored from 2012 to 2014 using:

- visual counts (video);
 - biotelemetry techniques;
 - CPUE abundance with electrofishing.
-
- Monitoring results show that several autochthonous species use the Coimbra fishway, including the diadromous sea-lamprey, Allis and Twaite shad and European-eel.

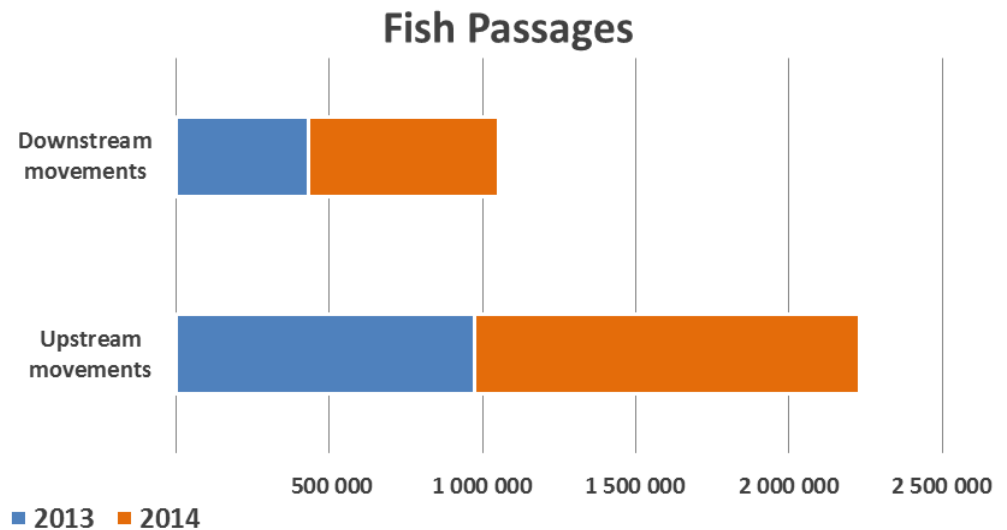
During 2013 and 2014 more than 3 000 000 million fishes used the Coimbra Fishway
